APE SERVICE BULLETIN

#44 HELICAL DRIVER CLAMP GREASE UPDATE

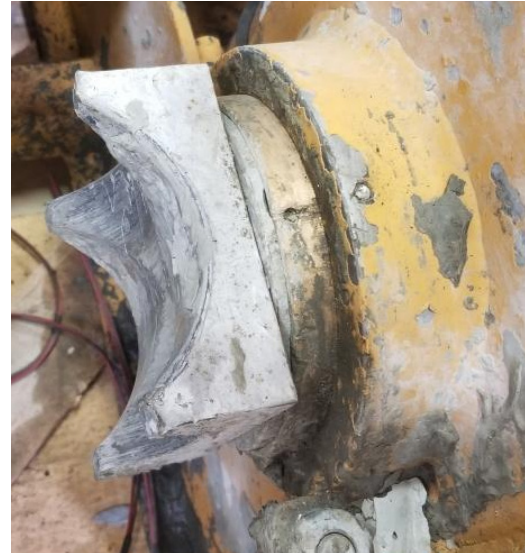
There have been a few HDC-13 clamps that had a problem with grout getting by the existing wiper, causing the bronze bushing to seize to the cylinder rod, pushing the bronze sleeve out of the clamp housing. To prevent this from occurring we have added an additional wiper. The secondary wiper retainer is to be welded to the outer tube of the cylinder assembly.

To complete the retrofit, the clamp will need to be fully disassembled for machine work and welding. Below is a table with the necessary parts to complete the retrofit.

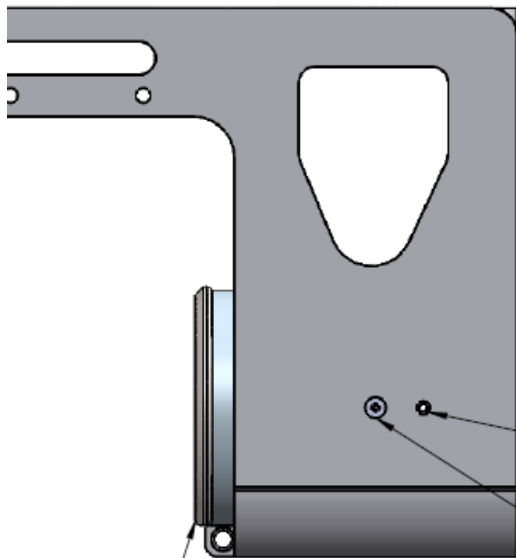
MODIFIED SHCS 1/2-13 X 5"

MACHINE FOR SET SCREW

MACHINE FOR GREASE ZERK

WIPER RETAINER RING

We have added a set screw and a grease zerk to both sides of each clamp cylinder housing. Machining is necessary to add the grease ports and set screws.
