# Corrosion of Steel Pilings in Soils

Melvin Romanoff

Reprinted from the Journal of Research of the National  
Bureau of Standards—C. Engineering and Instrumentation  
Vol. 66C, No. 3, July-September 1962

National Bureau of Standards Monograph 58

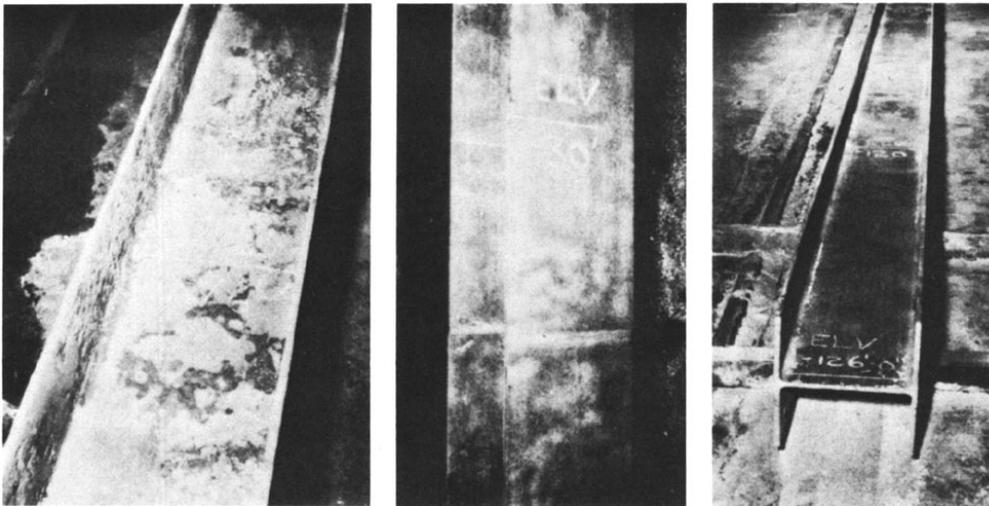
The pattern and amount of corrosion on the two piles were about the same. Corrosion was confined to two areas. One area extended from the top of the piles, which was above ground level, and extended through the zone exposed to the cinder and slag fill in the water table zone. The other corroded area occurred between elevations -115 to -118 ft where the piles passed through a sand and gravel bed.

-115 to -118: At this depth the piles passed through a sand and gravel stratum. The steel surfaces were uniformly corroded and contained many localized pits which generally ranged in depth up to 50 mils; 12 pits measured between 50 and 65 mils and 2 pits had depths of 80 and 95 mils. The average reduction in flange thickness measured 9 and 4 percent, respectively, for pile I-S and for pile II-S.

FIGURE 1. Sections of the 139-ft H-piles pulled from Sparrows Point, Maryland, after exposure for 18 years.

Left, water table zone consisting of fill material; center, clay soil stratum at about elevation -30 ft; and right, coarse sand and gravel stratum underlain by clay between elevations -110 and -126 ft. The pile was cleaned by sandblasting. Note the excellent condition of the butt weld at the splice in the center photograph.

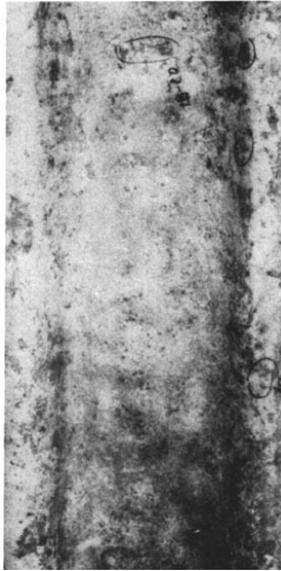
The entire length of the pile was driven below the water table. Corrosion was confined to a 2-ft section on the river side of the pile between elevation 59.8 to 61.8 ft. Pitting occurred in 11 places, each about 1 in. in area, along the fingers of the pile. The maximum pit depth was 26 mils and others ranged up to 22 mils. Several pits having a maximum depth of 20 mils were found in a 3-in<sup>2</sup> area in the center of the web. Ninety percent of the mill scale was intact in this moderately corroded zone. At least 95 percent of the original mill scale was found to be intact on the remaining areas of the pile, and no measurable pits or corrosion beyond the mill scale was observed. Based on the maximum pit depth, the total loss of pile thickness in the corroded zone could not exceed 5 percent of the original pile thickness.

FIGURE 2. Sandblasted 3-ft section from the 40-year-old piling extracted from an abutment wall in the Corps of Engineers Dam and Lock No. 8 on the Ouachita River near El Dorado, Arkansas.

The section was exposed about 18 ft below the ground line and it is the only portion of the pile which contained pits of measurable depth. The maximum pit was 26 mils in depth.

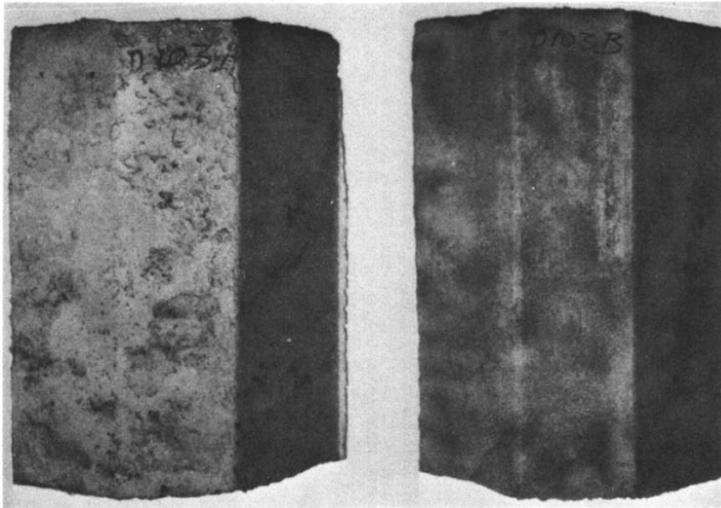
FIGURE 3. Sections (1.5 ft by 1 ft) cut from a piling which was pulled from the north upstream wingwall of the Grenada Dam Spillway at Grenada, Mississippi, after exposure for 12 years.

Sections were cleaned by sandblasting.  
 D103A, section of pile exposed to fill soil.  
 D103B, section of pile exposed to natural soil.

251.5 to 246.0 ft: Many scattered pits up to 30 mils in depth. Seven pits measured between 68 and 80 mils, and two pits 88 and 122 mils in depth. Pits were of similar depth on both sides of the pile, but much less numerous on the side facing the spillway. About 50 percent of the mill scale was intact on the spillway side and 10 percent on the other side. The reduction in cross section of the three most corroded areas measured between 6 to 8 percent of the original wall thickness.

244.0 to 237.5: About 75 percent of the mill scale was present over the surfaces in this zone. No measurable pits were found except two at elevation 241.0 ft which were 13 mils in depth. The average wall thickness of a 17 x 22 in. section removed from this zone was 0.37 in. after cleaning by sandblasting.

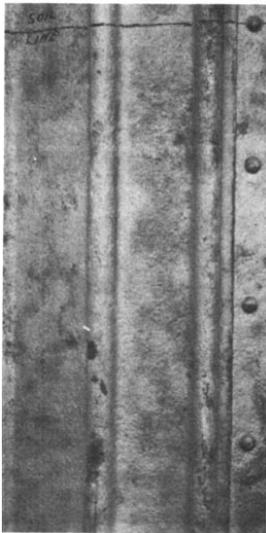
+2.5 to 0 ft: Section exposed to total or partial water immersion, or atmosphere. Uniform corrosion of surface. Measurements of the cross section in the top 6 in. of the piles (elevation +2.5 to +2.0) showed a minimum thickness of 0.06 in. in places. This represents a loss of 76 percent in the original pile thickness. The maximum thickness measured on uncorroded surfaces near the bottom of the piles was 0.26 in. Piles in the zone between +2.0 ft to the ground line showed a maximum reduction in thickness of 60 percent.

-1.0 to -3.0: Uniform corrosion, general roughening of surface, numerous shallow pits and many isolated pits up to 60 mils. Maximum reduction in cross section was 28 percent.

-3 to -17.5: In this zone the condition of the surface was similar to that described above, but was less severely corroded. Many isolated pits measured up to 30 mils in depth, and relatively few up to 60

FIGURE 4. A 3-ft section of steel sheet piling exposed below the soil line in a cofferdam structure in the Lumber River near Boardman, North Carolina. Exposure, 37 years.

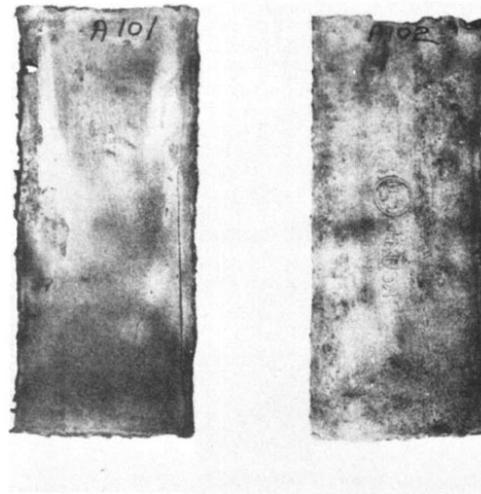
The coal tar coating was intact over the entire surface except at elevation 220.5 to 219.5 ft where the coating was damaged in an area 1-ft in vertical direction by 1-in. in width. The maximum depth of pitting of the steel exposed by the damaged coating was 35 mils (fig. 5). The steel beneath the rest of the coating was unaffected by corrosion and the mill scale was intact.

The entire surface of the pilings was in excellent condition. More than 90 percent of the mill scale was intact. There was very slight uniform metal attack in small localized areas. No measurable pits were found on the entire surface. From elevation 218 to the bottom of the excavated pit, the clay adhered very tightly to the piling. On removal, the soil peeled off in layers leaving free water on the steel surface.

FIGURE 5. Steel sheet piling sections (2 ft by 1 ft) cut from two locations on the Memphis Floodwall after exposure for 6.3 years.

The sections were cleaned by sandblasting. A101, section of coated piling showing pits up to 35 mils in depth, occurring in area of damaged coating. A102, section of uncoated piling exposed to a silty clay containing cinders showing no measureable corrosion.

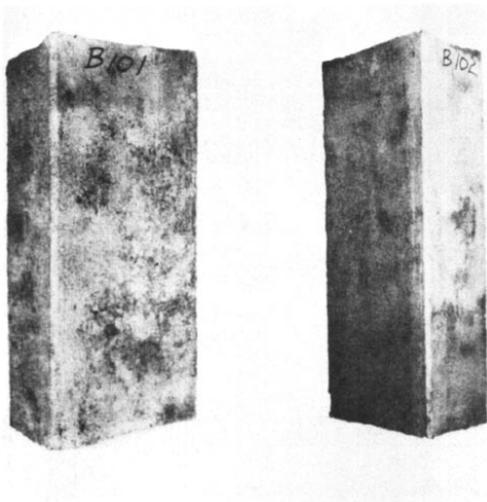
FIGURE 6. Sandblasted sections of Z-type sheet piling cut from two different locations in the Vicksburg Floodwall after exposure for 7 years.

Although cinders were present in the soil at both locations, no significant corrosion occurred.

Approximately 30 to 40 percent of the steel surfaces was covered with mill scale. Soil adhered in many areas of about 1-in. like barnacles, beneath which appeared uniform metal attack or shallow pitting. Pitting up to 40 mils in depth was widely scattered and confined to areas of less than 1 in.<sup>2</sup> At elevation 83.5 to 81.5 ft, there were a few pits with depths between 40 and 45 mils. Measurements made on the three most corroded 1 in.<sup>2</sup> areas showed an average reduction in the cross section of the web of 4 to 6 percent. A section removed from the most corroded area of the pile is shown in figure 6.

Mill scale was intact on about 70 percent of the piling surfaces. There was no difference in the appearance of the surface at the different horizons. Where the mill scale had been removed, there was a film of red rust which was brushed off with ease. Under the rust, the steel surfaces were smooth. No measureable pits were found on the exposed pilings. Measurements fail to show a perceptible reduction in wall thickness (fig. 6).
