# Corrosion of Steel Pilings in Soils

Melvin Romanoff

Reprinted from the Journal of Research of the National  
Bureau of Standards—C. Engineering and Instrumentation  
Vol. 66C, No. 3, July-September 1962

National Bureau of Standards Monograph 58

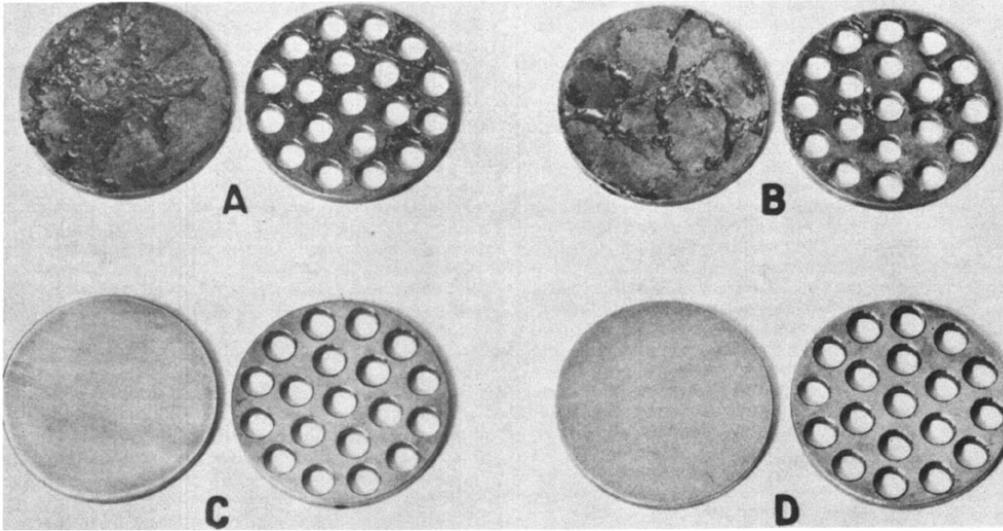
FIGURE 7. Corrosiveness of soil samples from Bonnet Carre Spillway as indicated by electrode weight losses after 6 months in modified Denison corrosion cells.

Electrode sets A and C set up under aerated and unaerated conditions, respectively, with soil samples obtained at 22 ft depth from surface of ground. Electrode sets B and D set up under aerated and unaerated conditions, respectively, with soil samples obtained at 45 ft depth.

exposure in the laboratory under aerated and un-aerated conditions are shown in figure 7.

It was previously pointed out that the soil samples from the piling which was extracted from the Bonnet Carre Spillway had properties similar to those of the severely corrosive Docas clay soil in the NBS field tests. The laboratory corrosion cell set up under the aerated conditions produced weight losses of the same order of magnitude for the Bonnet Carre (fig. 7, A and B) and Docas clay soils [1,16] indicating that the Bonnet Carre soil is equally as corrosive as the Docas clay soil under aerated conditions. The weight losses of ferrous pipe specimens which were exposed in the disturbed soil at the Docas clay site are in relatively good agreement with the results obtained in the laboratory under aerated conditions.

On the other hand, the piling extracted from the Bonnet Carre Spillway after exposure for 17 yr was unaffected by corrosion at all depths below the water table zone, and showed but a negligible amount of corrosion in the water table zone. This is in complete accord with the results from the laboratory cell test which showed a relatively negligible amount of corrosion for the cell electrodes set up under un-aerated conditions as compared with that of the cell electrodes set up under aerated conditions.

The importance of oxygen as a factor in the corrosion process was previously indicated, by the behavior of steel in the modified Denison corrosion cell set up under aerated and unaerated conditions in the laboratory on soil samples from the Bonnet Carre Spillway (fig. 7).
